Water renovation Kynastteich, Berlin, Germany

Operation
1 Park ring pond 3000 m³ with OLOID Type 400

Period
Since 08/2015

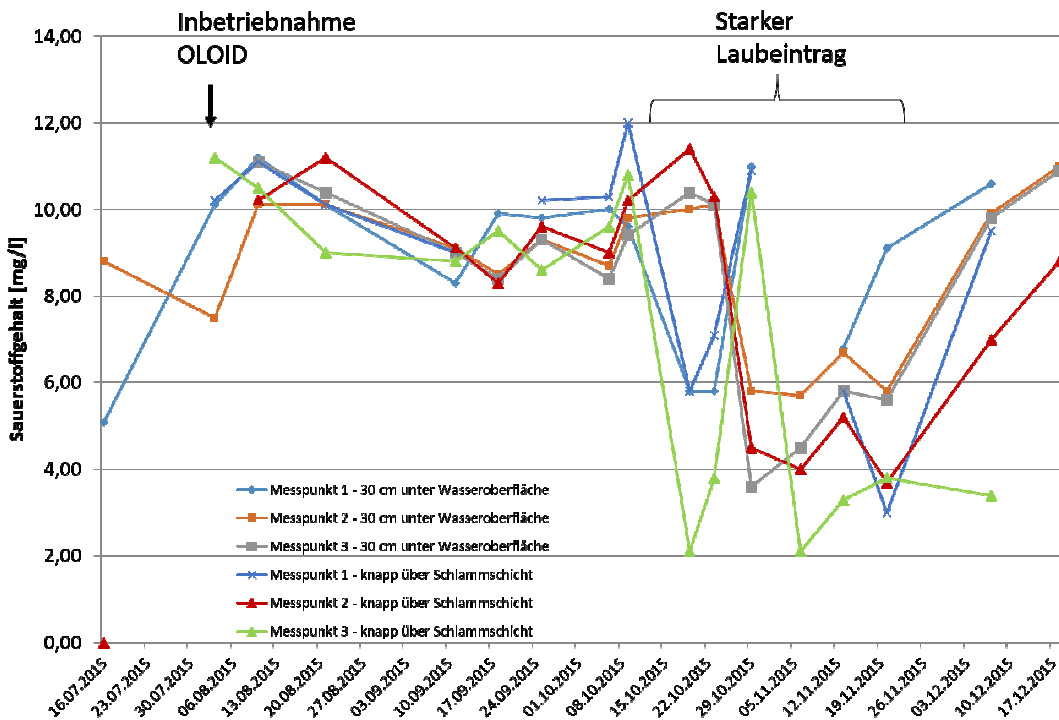
The oxygen measurements show that with initiation of the OLOID, oxygenation takes place. The oxygen content tends to decrease with depth which is typical for standing waters. Here it can be seen that the OLOID initiated oxygenation. Until the middle / end of October 2015 it can be seen that a good to very good saturation is documented of oxygen in water. The end of October / November 2015 lower oxygen levels were measured, this is likely to be linked to the death of aquatic plants and the high foliage entry and thereby initiated ablation process. Mid-December 2015 were again higher oxygen contents and a nearly oxygen saturation measured. Reasons for this are in addition to the operation of the OLOID also in the temperature dependence of both the solubility of oxygen in the water and the microorganisms activity on the other.

Before OLOID installation an additional water entry between 05/20/2015 and 07/15/2015 of approximately 1.176m³ was done to raise the water level. On 08/03/2015 an OLOID Type 400 was installed. During a 4-month period (until week 50) weekly visual water inspection and oxygen measurements were carried out (results are in the graph on page 3).
