Water renovation Kynastteich, Berlin, Germany

Operation
1 Park ring pond 3000 m³ with
OLOID Type 400

Period
Since 08/2015

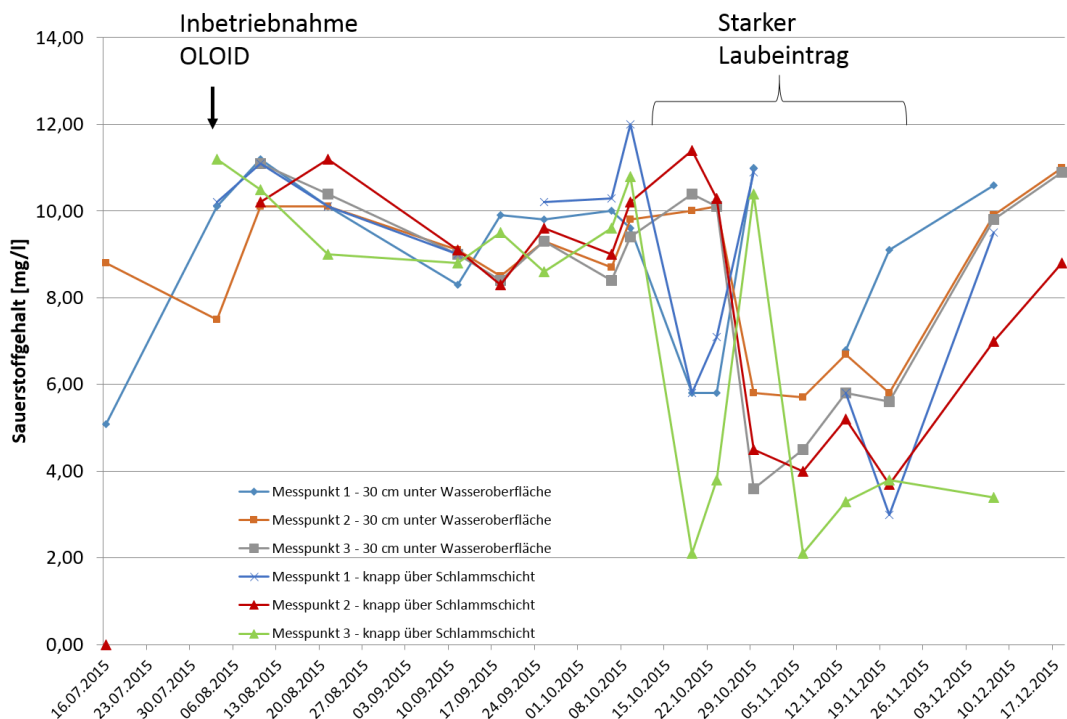
The oxygen measurements show that with initiation of the OLOID, oxygenation takes place. The oxygen content tends to decrease with depth which is typical for standing waters. Here it can be seen that the OLOID initiated oxygenation. Until the middle / end of October 2015 it can be seen that a good to very good saturation is documented of oxygen in water. The end of October / November 2015 lower oxygen levels were measured, this is likely to be linked to the death of aquatic plants and the high foliage entry and thereby initiated ablation process. Mid-December 2015 were again higher oxygen contents and a nearly oxygen saturation measured. Reasons for this are in addition to the operation of the OLOID also in the temperature dependence of both the solubility of oxygen in the water and the microorganisms activity on the other.

Before OLOID installation an additional water entry between 05/20/2015 and 07/15/2015 of approximately 1.176m³ was done to raise the water level. On 08/03/2015 an OLOID Type 400 was installed. During a 4-month period (until week 50) weekly visual water inspection and oxygen measurements were carried out (results are in the graph on page 3).
